Effective SAFETY Solutions

Company: Real Alloy Germany GmbH

Business: Aluminium Recycling

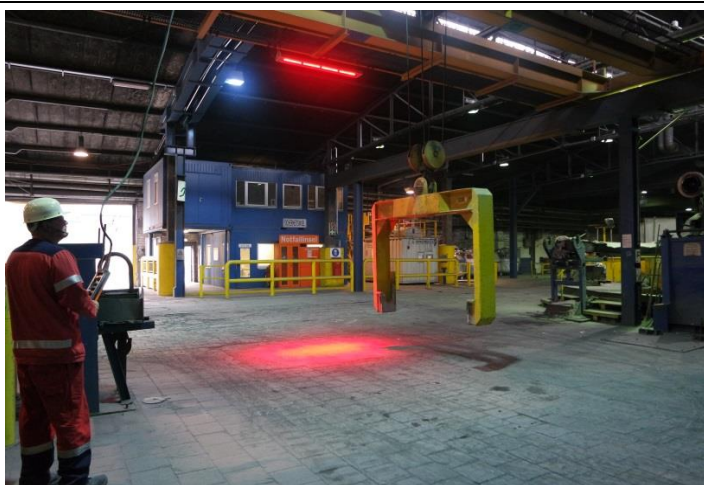
PICTURES (if applicable) or ADDITIONAL INFO

Due to this issue we developed other solutions to warn employees. A LED spot fixed to the overhead crane is marking the actual position of the crane on the ground. The first advantage is that we no longer need the acoustical warning for the cranes and have thus reduced the noise in the production area. As a second improvement the LED is permanently on and warns the employee - without the deafening by an alarm which is making noise all the time.

- Noise reduction
- No deafening by permanent acoustic alarms
- Low installation costs
